August 15, 2015

Exeter Place

Regarding: FY2016 - Level I Capital Replacement Reserve Study

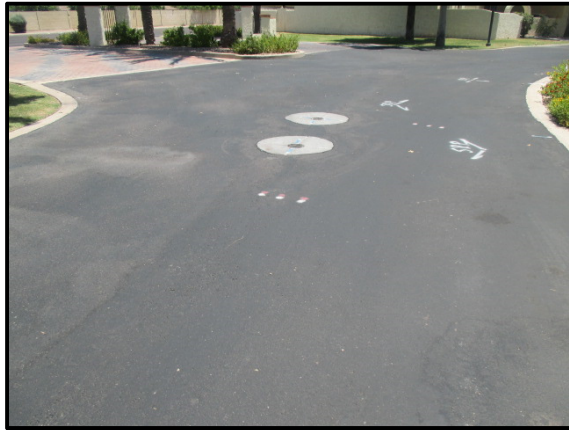
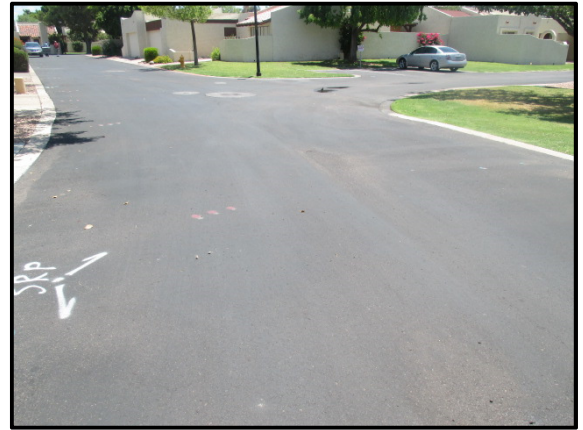
Asphalt – Remove & Replace

Asphalt pavement comprises approximately 47,250 square feet of private streets. These surfaces were completely resurfaced during 2012. Total replacement includes the removal of all existing asphalt down to the base course of aggregate and native soil followed by the application of two or more new lifts of asphalt. Based on our visual observations and client history, we recommend a mill and overlay application for initial repaving followed by the total replacement application for subsequent repaving.

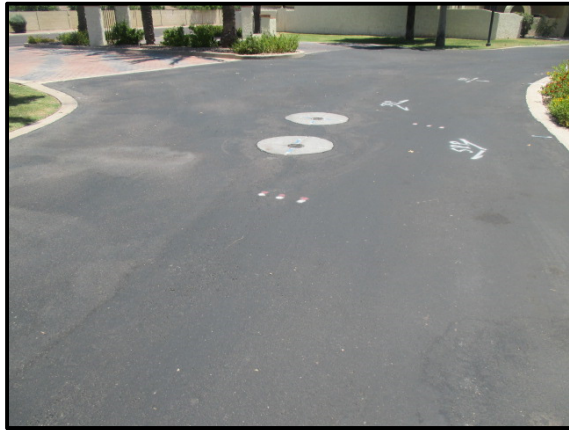
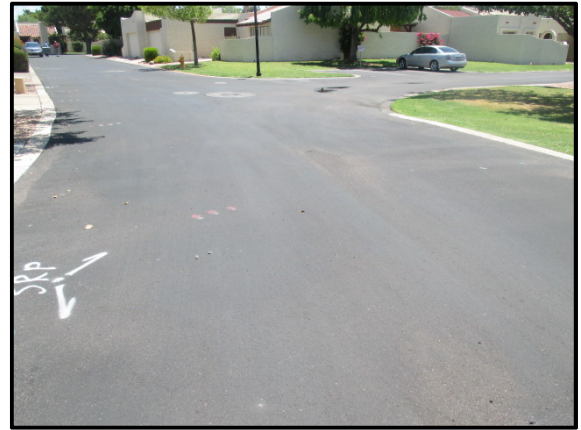
Asphalt pavement comprises approximately 47,250 square feet of private streets. These surfaces are in good condition at an age of 4 years. Asphalt pavement typically has a useful life of 15-20 years. Components of asphalt included native soil, aggregate and asphalt. This component budgets for a Mill and Overlay application at a 15 year interval. A Mill and Overlay is a method of repaving where cracked, worn and failed pavement is mechanically removed or milled until sound pavement is found. A new layer of asphalt is overlaid atop the remaining base course of pavement. **Note:** Cost estimate based on research with Ace Asphalt

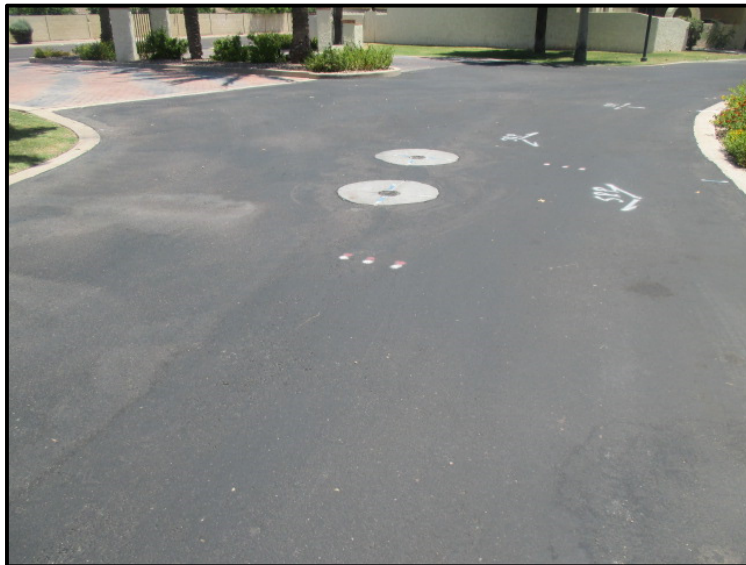
Asphalt – Seal/Repair

The asphalt streets were resurfaced during late 2012 early 2013, we are using 2012 as the installation date for budgeting purposes. Asphalt surfaces should be sealed approximately every 3-4 years in order to maintain and prolong the expected useful life. Inspect annually, fill cracks and treat minor repairs out of the operating budget.

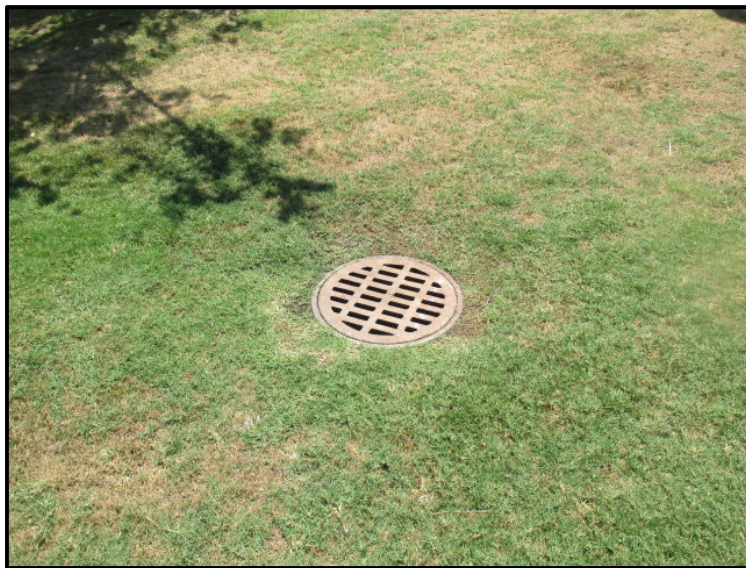
This component provides funding to periodically cleanout the (5) Drywells at Exeter Place. We recommend inspections annually and cleanouts when needed to ensure the functionality and longevity of the Drywells.

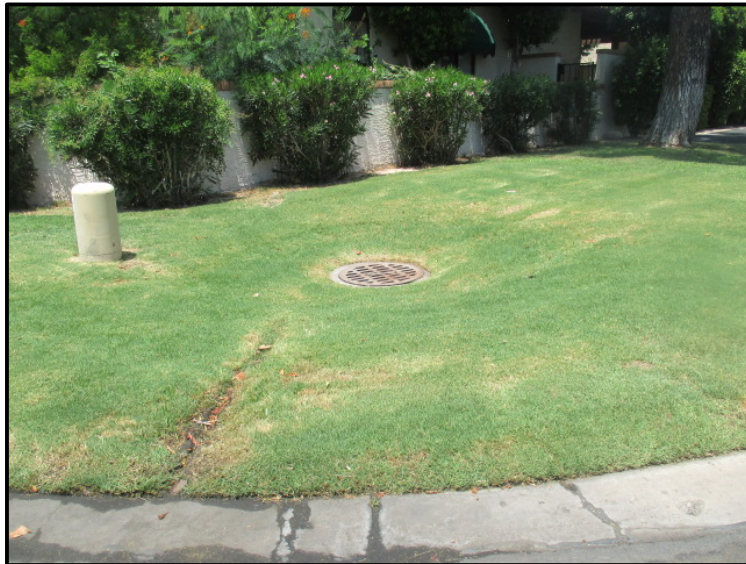
Drywells – Partial Replace

Actual installation date unknown at this time. There are (5) Drywells located throughout the property. No reported issues. Drywells should be inspected annually and cleaned out on a regular basis to ensure longevity. This line item provides funding to completely replace one of the five Drywells. Drywell failure can be caused by improper installation, poor drainage or neglect. We recommend planning replacement of one Drywell at roughly the cost and time frame listed above.

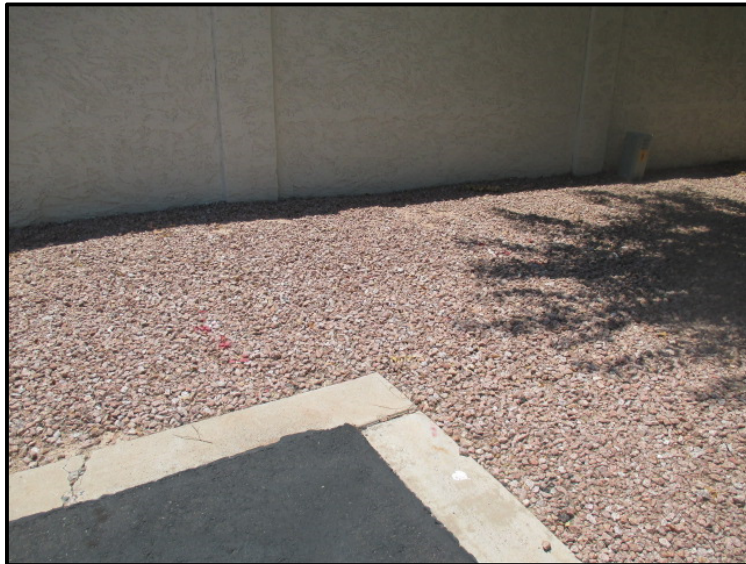
Over time, with rains, irrigation, silting, and being tread upon, granite is ground into smaller pieces and loses its fullness. To avoid exposed patches of dirt, we recommend periodic top dressing of the landscape rock. There is approximately 15,637 square feet of landscape rock located throughout the property. This component budgets to replenish 100% of the total square footage with 1/2" rock at 1" deep which converts to approximately 130 tons of rock. Recommend replenishment at roughly the timing and cost listed above.

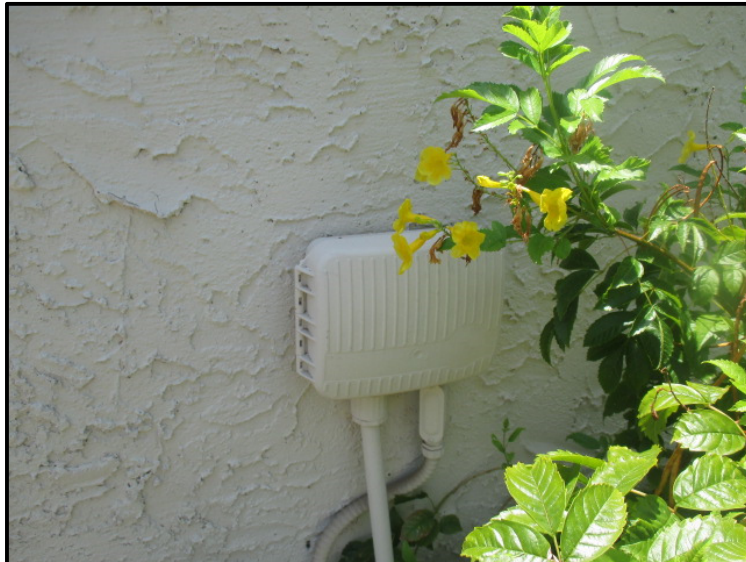
The irrigation system waters the turf common areas at Exeter Place. This system includes backflow preventers, pop up heads, valves, lines and controllers. The entire system was replaced during 2013-2015. We are using 2014 as the average installation date for the irrigation lines. This component budgets to replace all of the irrigation lines, heads, and valves on a 30-year cycle. The pipes will dislodge as tree roots grow and soil conditions change. Exeter place should anticipate inspections and partial replacements of the system lines and other components every 5 years. Minor replacements and repairs should be handled out of the Operating budget, this line item budgets for a major refurbishment of the irrigation system.

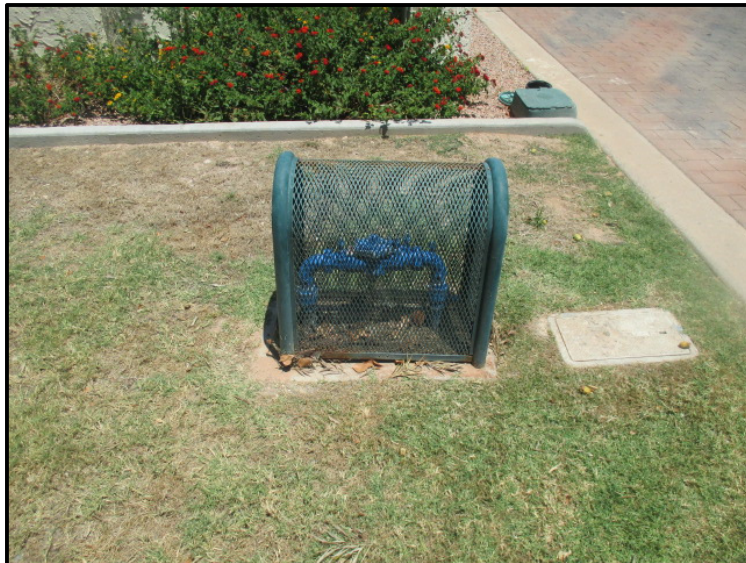
Backflow Valves – Replace

There are approximately (52) backflow preventers located throughout the property. Forty two of these units were replaced during 2012. See table below for cost and timing estimates. Inspect annually by qualified professionals. No reported or observed issues. Replacement should be anticipated at some point in the future.

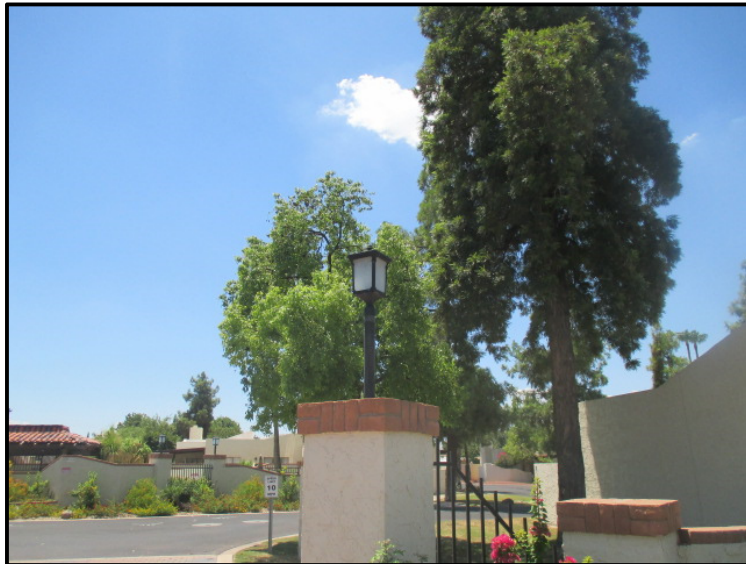
Outdoor Lighting - Replace

The client spent approximately \$4,788 during 2007 to replace the outdoor lighting. Outdoor lighting typically has a long useful life. Individual repairs and replacements should be handled as an operating expense. This component budgets to replace all of the outdoor lighting in the future.

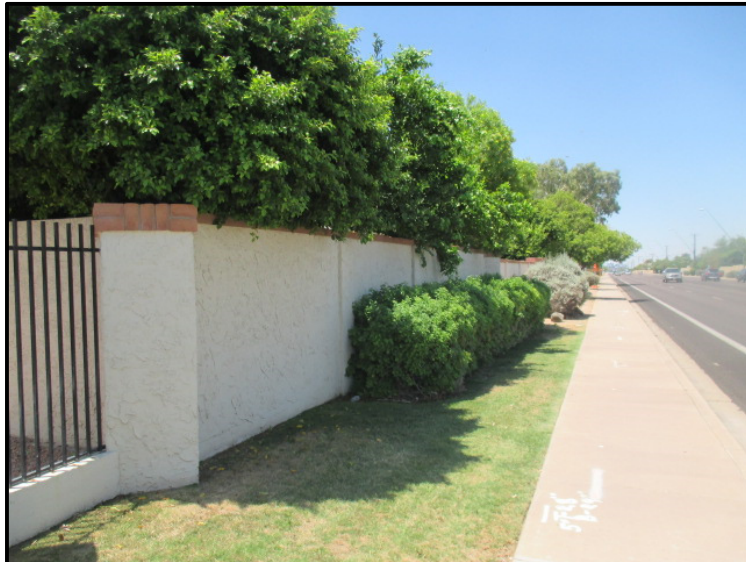
Walls – Repaint + Repair

There is approximately 14,500 square feet of stucco walls located at Exeter Place. This line item includes funding to repaint the walls on an 8-year cycle as well as additional funds for stucco repairs. No major signs of cracks, peeling, or deterioration noted. These surfaces are in fair overall condition.

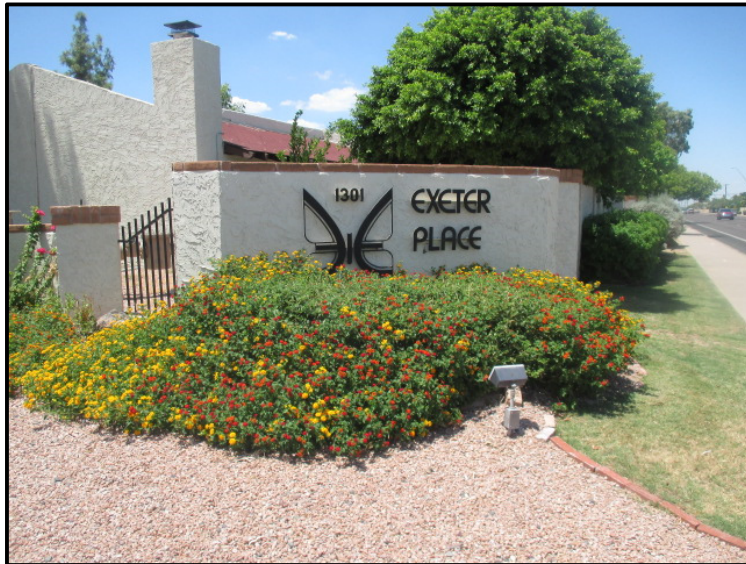
Monument Signs - Replace

There are (2) metal monument signs located at the community entrance. Installed during 2012. Observed to be in good condition. Future replacement should be anticipated at roughly the cost and time frame listed above.

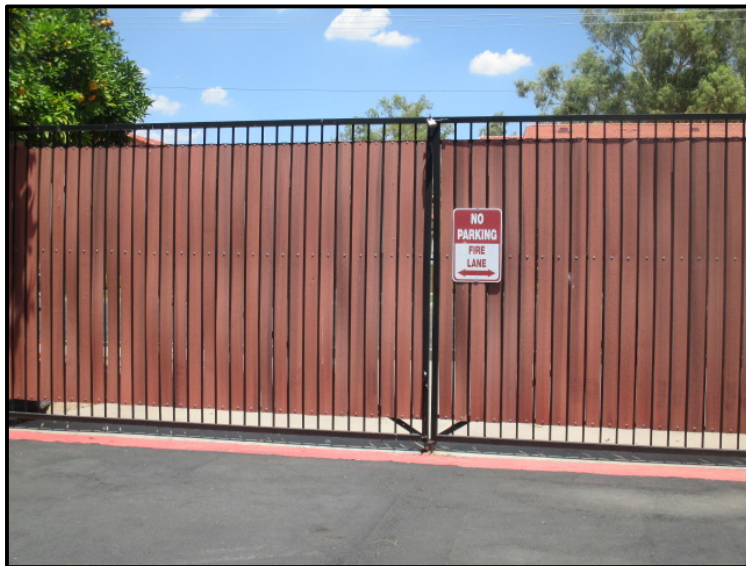
Metal Gates - Replace

This component includes (2) metal gates: (1) pedestrian gate and (1) fire lane gate. Installed during 2015. No damage noted. Future replacement should be anticipated.

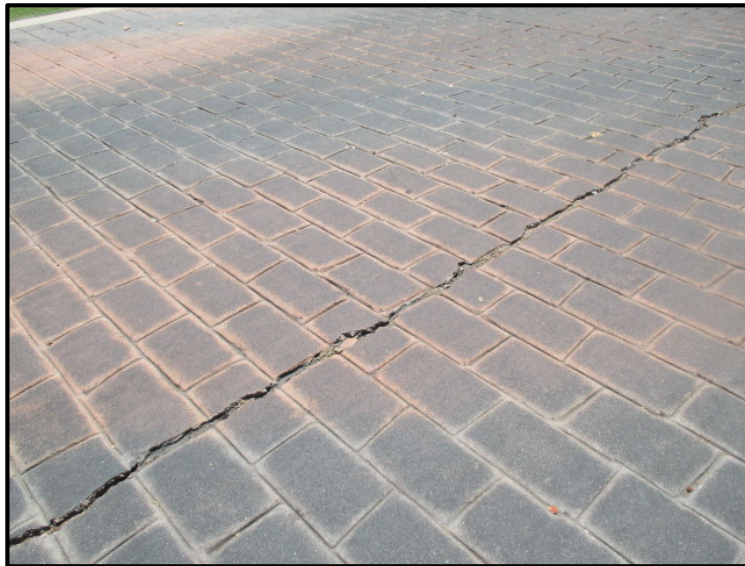
The association maintains 2,370 square feet of concrete entry surface area. Large cracks noted throughout the entry concrete area. Concrete surfaces typically have a useful life of up to 65 years although partial failures and deterioration is common. Weather conditions, installation methods and finishing techniques can result in premature deterioration such as cracks, chips and spalls. Various conditions like these result in the need to plan for periodic partial replacements over the next 30 years. Due to the high visibility of these surfaces, we recommend planning complete replacement during 2016.

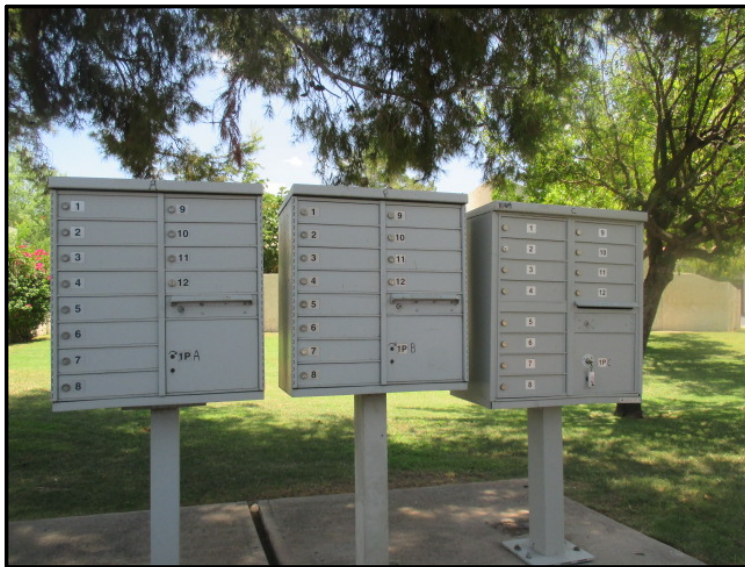
There are approximately (5) mailbox clusters located throughout the property. Clusters appear to be in good shape and still intact. Recommend replacing during 2025. Replacement boxes should comply with US Postal standards.

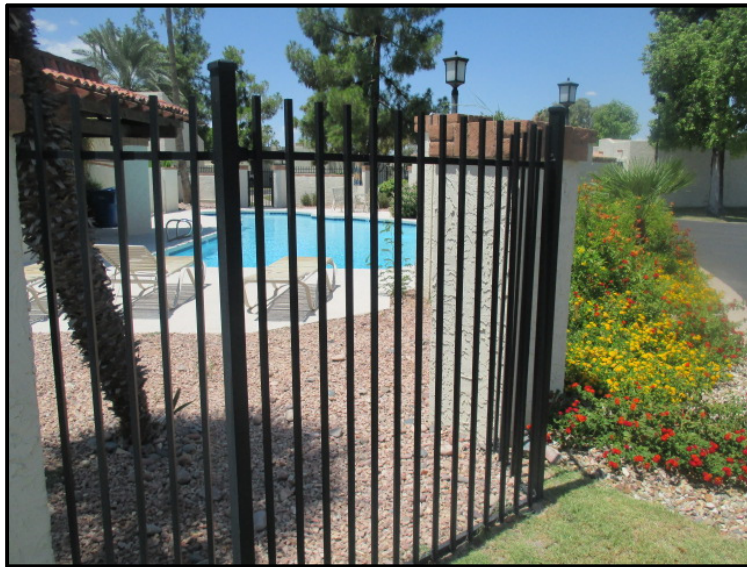
This component includes metal fencing surrounding the pool perimeter and metal fence sections at the community entrance. Installed during 2005. Still intact and in fair condition. There is approximately 75 linear feet of 6 foot high metal fencing. Repaint out of the operating budget. Regular cycles of repaint will help protect and prolong the useful life of the fence.

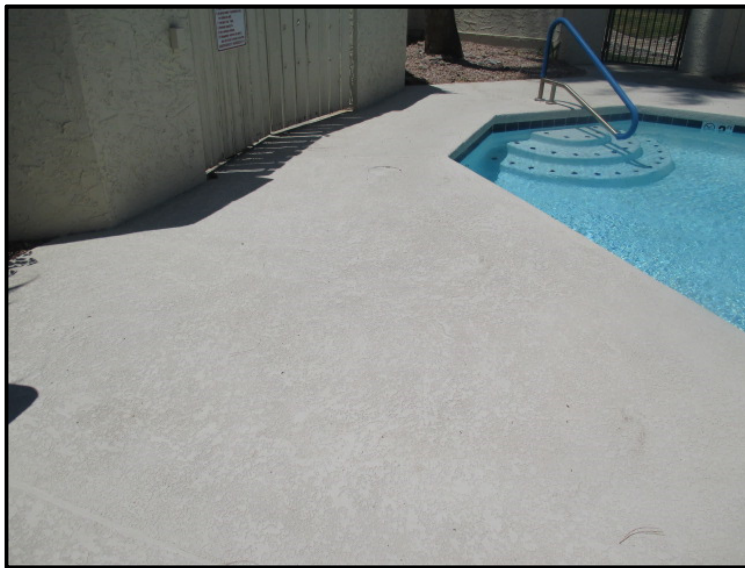
There is approximately 1,600 gross square feet of acrylic lace pool deck at the Pool Area. These surfaces were completely resurfaced during 2015. We recommend budgeting to repaint and repair minor cracks every 6 years.

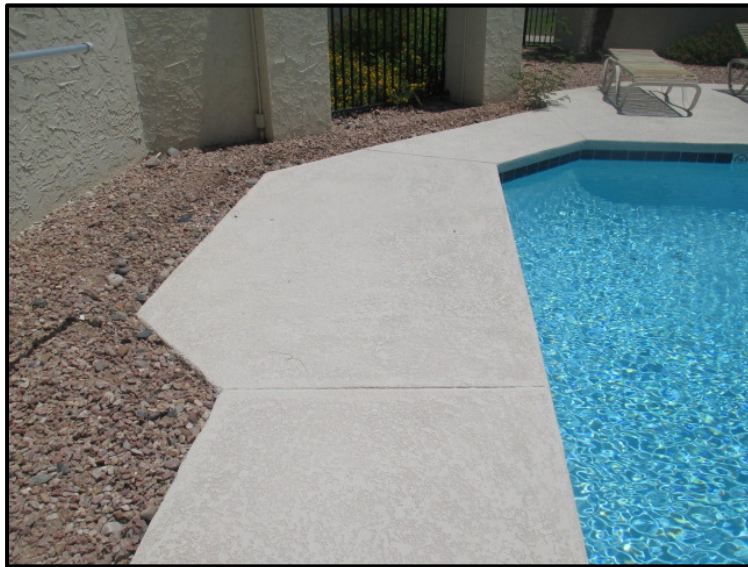
There is approximately 1,600 gross square feet of acrylic lace pool deck at the Pool Area. These surfaces were completely resurfaced during 2015. We recommend budgeting to repaint and repair minor cracks every 6 years. This component budgets to completely resurface the pool deck at roughly the time frame listed above.

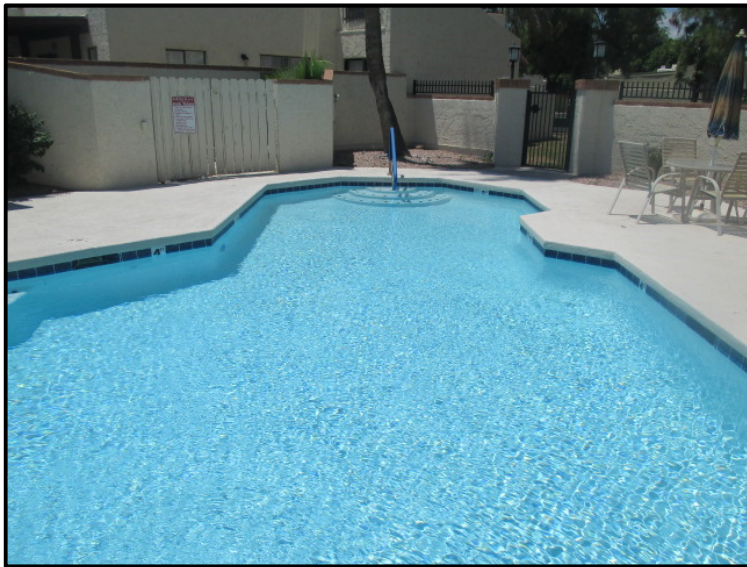
This pool was resurfaced with new plaster during 2015. As part of the replaster work, new pool lights were installed and the water line tile was bead blasted and cleaned. Surface observed to be new and in good condition. Future replacement should be anticipated in the future.

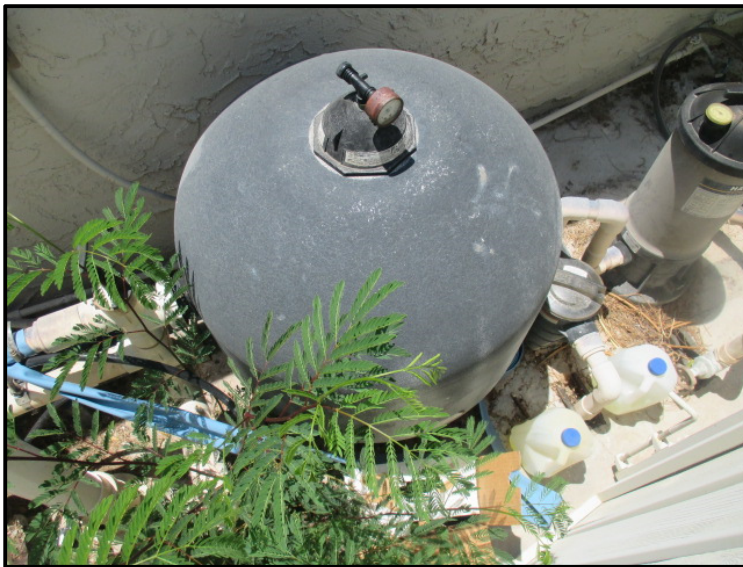
Actual age unknown at this time. Appears to be older but still functional. Recommend planning replacement at some point in the near future.

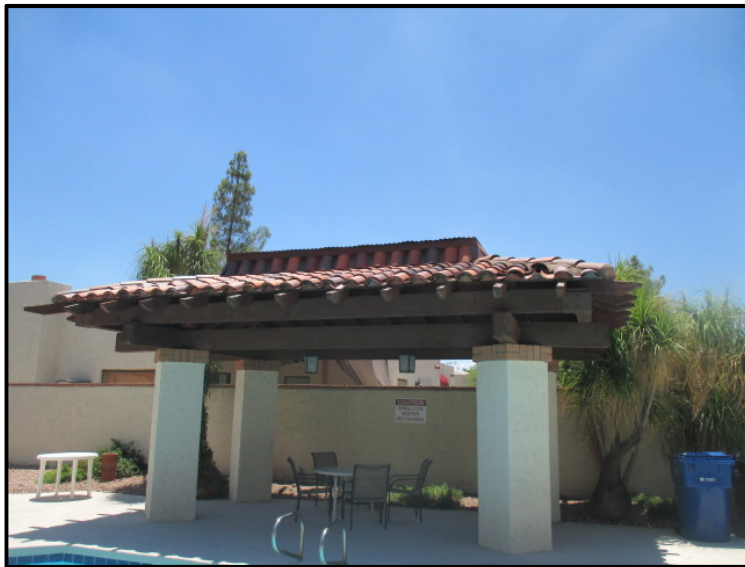
Actual age unknown at this time. Good conditions observed from our ground-level inspection. As routine maintenance, we recommend professional inspections annually. We recommend budgeting for removal of the tiles and underlayment, installation of (2) layers of new 30# felt underlayment and reinstallation of original tiles.

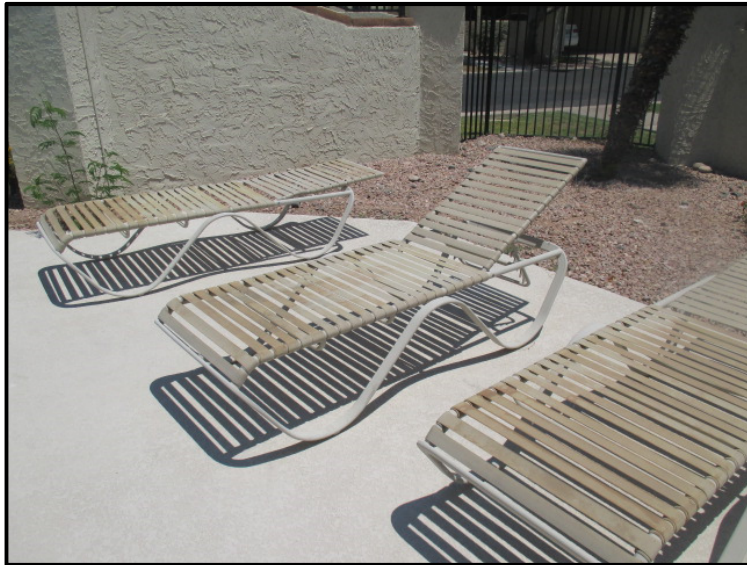
This furniture includes (8) dining chairs, (3) chaise lounges, (2) round dining tables, (1) umbrella and (1) tea table. The age of the miscellaneous pieces varies. We recommend replacement of these pieces during 2016.

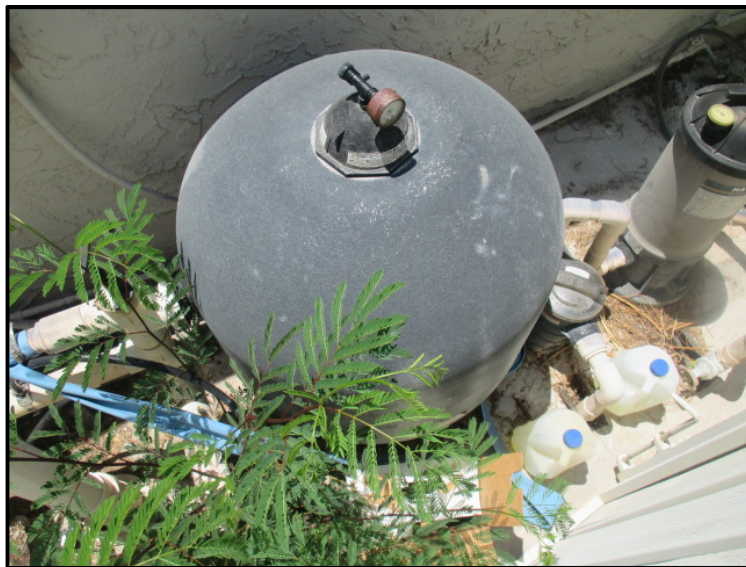
Actual age of these pumps unknown at this time. This component provides funds to replace these pumps on a 10 year cycle. Individual motor replacements should be handled out of the operating budget.
